Rivers ranked according to the available potential for spawning of river lamprey and proposed improvement measures to secure river connectivity, Kurzeme Region

**Project: Cross-boundary evaluation and management of lamprey
stocks in Lithuania and Latvia
LAMPREY LLI-310**

**Institute of Food Safety, Animal Health and Environment "BIOR"
Rīga, Latvija**

2020

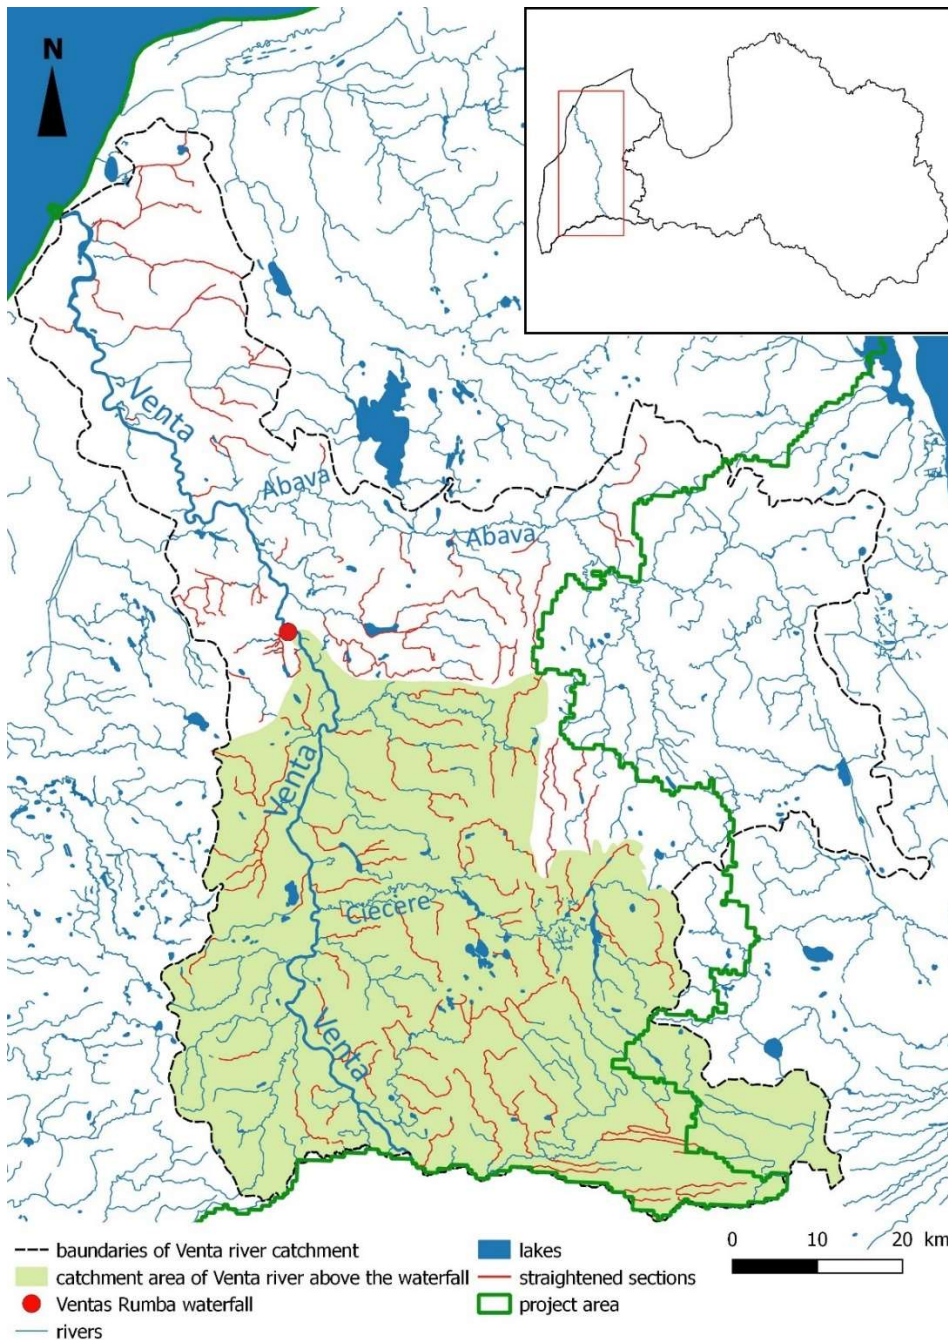
Figure 2.1.2 Catchment of River Venta and location of barrier

River Venta is the largest stream in Kurzeme region. It sources in Lithuania, crosses Kurzeme and empties into Baltic Sea in territory of Ventspils City. River Venta is natural salmon *Salmo salar* spawning river, great part of its riverbed is included in two Natura 200 territories – “Ventas ieleja” (The Valley of River Venta) and “Ventas un Šķerveļa ieleja” (The Valley of rivers Venta and Šķervelis) which among other is designated for protection of anadromous species. Hydromorphological alterations of riverbed of River Venta in territory of Latvia are minor. Greatest changes can be found next to river mouth where river is embanked and deepened to meet the needs of Freeport of Ventspils. There are almost no noteworthy man-made changes in other parts of this river but such alterations as straightening of riverbed, exploitation of small HPS and presence of other man-made barriers can be found in many tributaries of this river and also in its upper reach in territory of Lithuania. Most important barrier in this river is waterfall Ventas Rumba located in Kuldīga Town. There are also a large number of small HPS and other barriers in many tributaries of this river both above and below of this waterfall. Most important barriers located in rivers downstream this waterfall will be viewed in separate chapters.

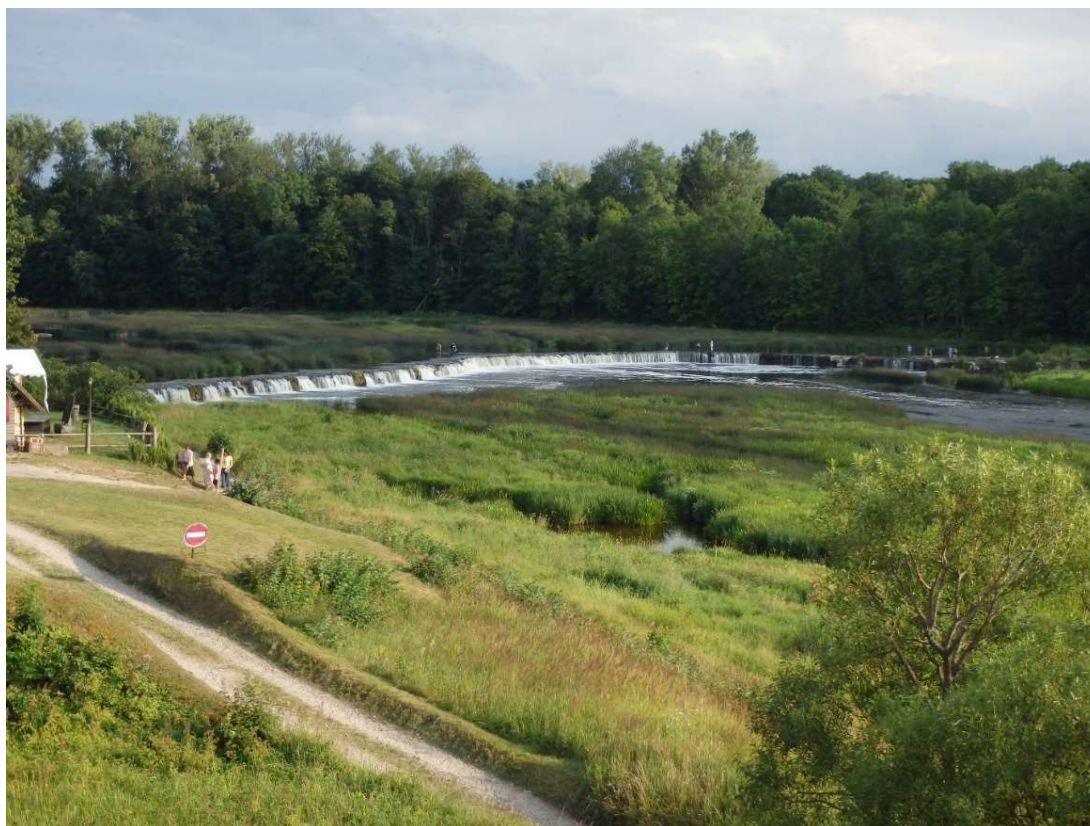
Figure 2.1.2. View on Ventas Rumba Waterfall

Waterfall Ventas Rumba is located 86 km upstream the river mouth in Kuldīga town. Its average height is ~2 m and it is the widest waterfall in Europe (Figure 2.1.1.). Waterfall and its surrounding area have a status of protected geomorphological object, it is located in territory of Natura 2000 site “Ventas ieleja”. In 17th century and repeatedly in 19th century there were attempts to build a bypass channel for shipping purposes around this waterfall on the right bank of River Venta. Unfortunately, these plans did not succeed yet the remains of the unfinished channel may occasionally be flooded and serve for some sort of fish pass. Nevertheless, in general Ventas Rumba waterfall is not passable for migrating lampreys with the exception of periods of very high water levels.

Possibility of building artificial structures to facilitate the lamprey migration over this barrier is limited due to its status. Theoretically it may be possible to modify the unfinished bypass channel to adapt it for fish migration yet realisation of this activity would require a large investment of time, engineering and money and would not grant the results. The most suitable mitigation measure for this barrier is stocking of larvae. Translocation of spawners has also proved its utility yet it needs to be taken into account that lamprey population upstream the barrier is genetically distinct from lamprey population of Latvia and Lithuania and may provide important information for the study of lamprey evolution and evolution in general. It is possible that large-scale translocation projects may affect the genetical structure of lamprey population upstream of the barrier, therefore such actions should be avoided.

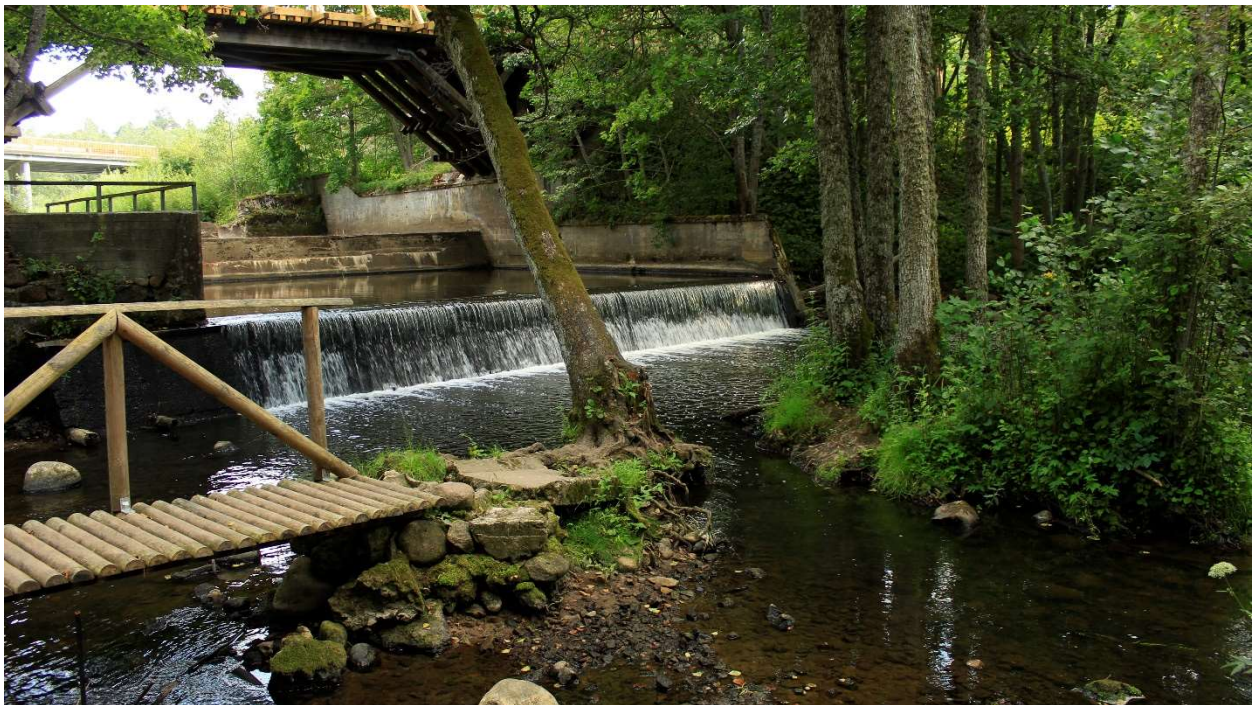
Figure 2.2.3 Remains of unfinished cardboard factory dam in River Rīva

Barrier is located in lower reach of the river and consists of three parts. In downstream part there is approximately 1,2 m high waterfall (Figure 2.2.3), in upstream direction followed by ~ 1.2 m high concrete wall with narrow (approximately 30 cm opening in right coast side) and by ~1,5 m high concrete block with integrated 1 m diameter pipe in the centre and half-pipe in upper right corner. This construction is remains of unfinished cardboard factory dam built in 1920, however there is information that watermill in this site existed already in 18th century and later was replaced by papermill destroyed during the World War I. Today dam is a tourist attraction for visitors of the nearby cafe and a wooden bridge. Barrier might be passable for river lamprey at very rare and specific conditions.

Best mitigation measure would be the complete removal of the barrier. It would not only ensure the migration for river lamprey, sea trout, European eel *Anguilla anguilla* and other fish species but also lower the water level in section upstream of the barrier. Yet complete removal of this object faces strong opposition from the local community and other stakeholders and therefore is currently not possible. Second best option is building of bypass channel/fauna passage which is planned within Interreg project “Development, Promotion and Sustainable Management of the Baltic Sea Region as a Coastal Fishing Tourism Destination” RETROUT. Potential of river lamprey reproduction both in the main river and its tributaries can also be increased by restoration of riverbed.

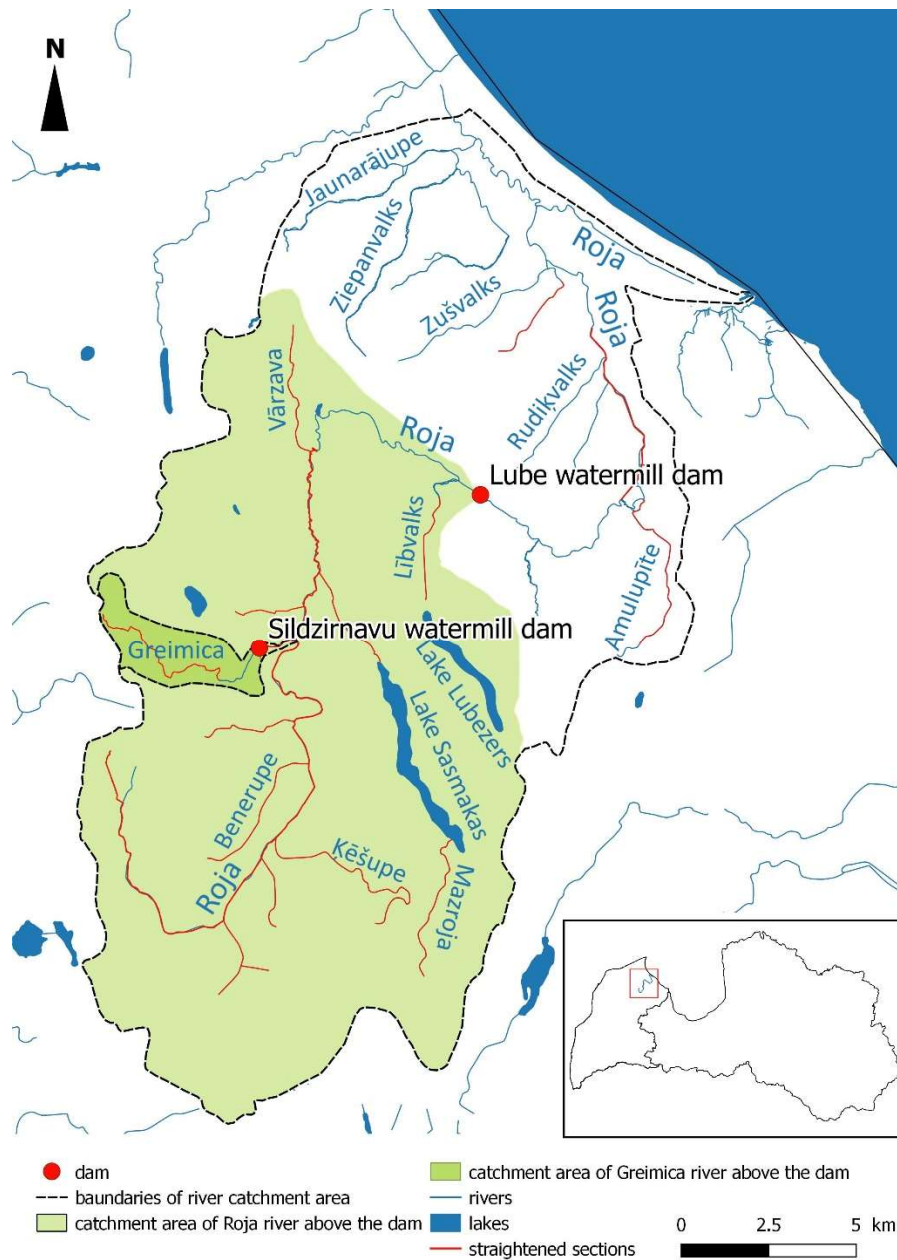
Figure 2.3.1 catchment of River Roja and location of most important barriers

River Roja is the largest river emptying into western part of Gulf of Riga (Figure 2.3.1). Roja is approximately 80 km long; its catchment area covers 480 km² and average slope of the riverbed is 0.61 m/km. Upper and middle reaches of River Roja together with most of its tributaries as well as some

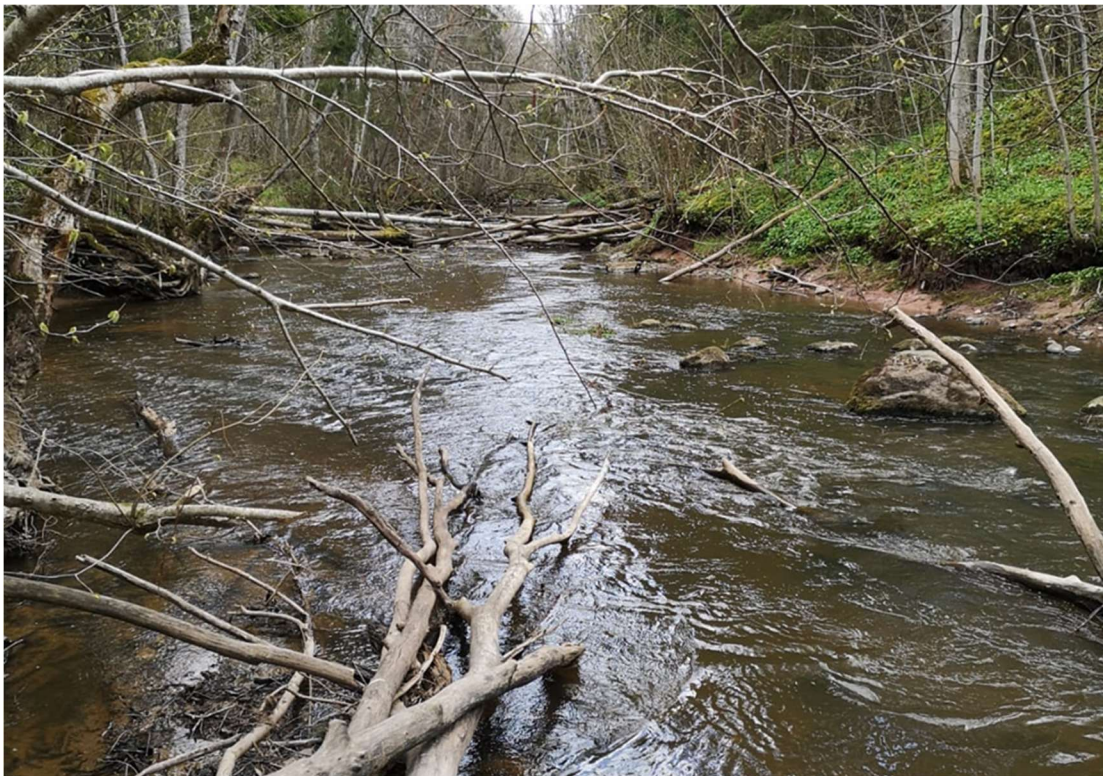
Figure 2.3.2 River Roja downstream of the dam

Detailed information of fish habitats in River Roja is not available. However, monitoring of lamprey larvae confirms that downstream the barrier River Roja is well suited for river lamprey reproduction (Figure 2.3.2) and reproduction of brook lamprey happens also upstream the barrier.

In section downstream of the barrier monitoring of lamprey larvae is being performed since 2013 and average density of lamprey larvae since then has been approximately 30 ind./m². Upstream of the dam monitoring of lamprey larvae was performed in 2018 and 2019 with the aim to evaluate the success of translocation of lamprey spawners within the LAMPREY project. Results of monitoring of lamprey larvae show that lamprey reproduction upstream of the dam occurs both in natural section of riverbed (density from 10 to 15 ind./m²) and also in downstream part of straightened section (average density 7.7 ind./m²).

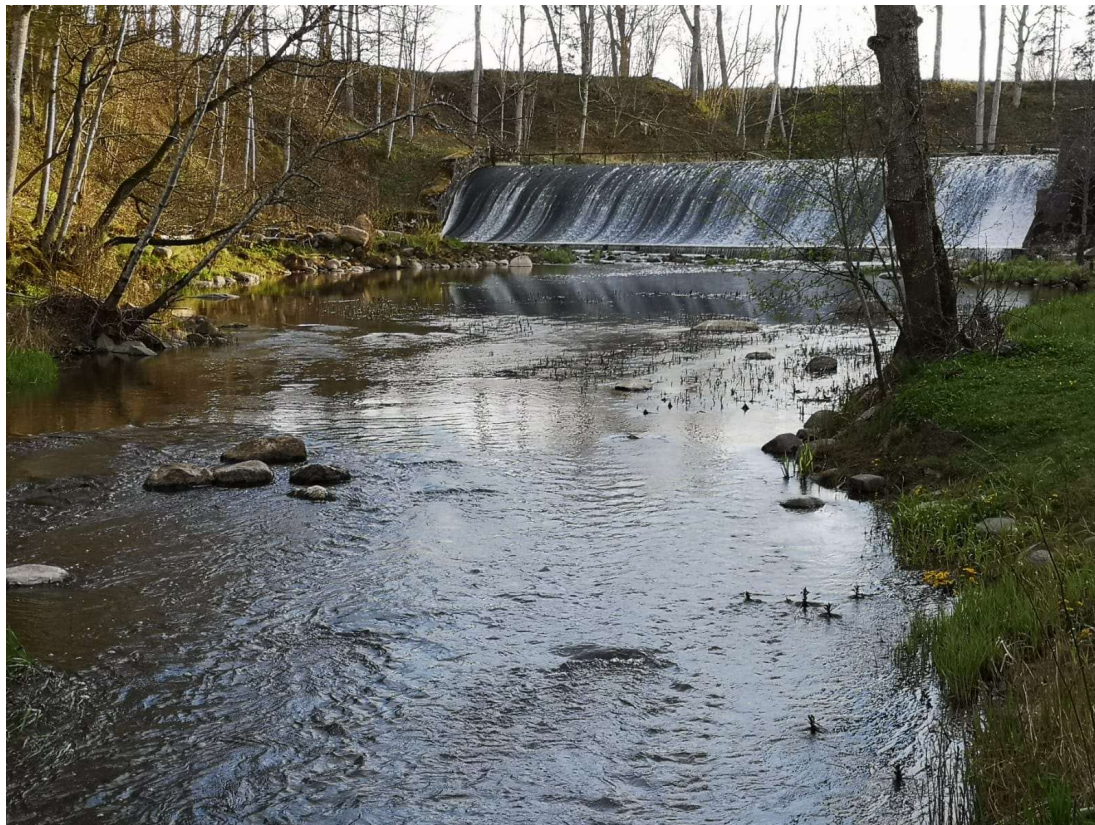
Figure 2.3.3 Dam of former Lube Watermill

Dam of former Lube watermill is located in middle section of River Roja approximately 32.5 km from the river mouth. It is a solid concrete dam with a regulator of water level and as such completely impassable for river lamprey or other migratory fishes (Figure 2.3.3). There is information that watermill in this place existed already in the end of the 16th century. Lube watermill during its existence was reconstructed several times and exploited as watermill until the second half of the 20th century. There were also plans to use mill dam for construction of small HPS yet luckily these plans were not realised. Today dam and reservoir are not directly used for economic activity. The most effective measurement for this barrier would be the complete or partial removal of dam. Such action would not only ensure the migration of river lamprey, sea trout and other fishes but also improve the quality of river affected by impoundment. However, experience with other dams shows that complete removal of such barriers often face resistance from owners and other stakeholders and thus is very complicated or is not possible at all.

If complete removal of this barrier is not possible, the second-best solution is to build a bypass channel/fauna passage. If building of such fish pass is not possible it can be replaced by technical fish pass targeted for ensuring the migration of lamprey and sea trout. However technical fish pass is a compromise solution with limited efficiency and should be replaced with natural fish pass or removal of dam when possible. As a short-term solution yearly translocation of river lamprey spawners from commercial fishery in River Roja is suggested. It needs to be taken into account that great part of River Roja and its catchment is straightened and lamprey reproduction potential can also be greatly increased by restoration of riverbed.

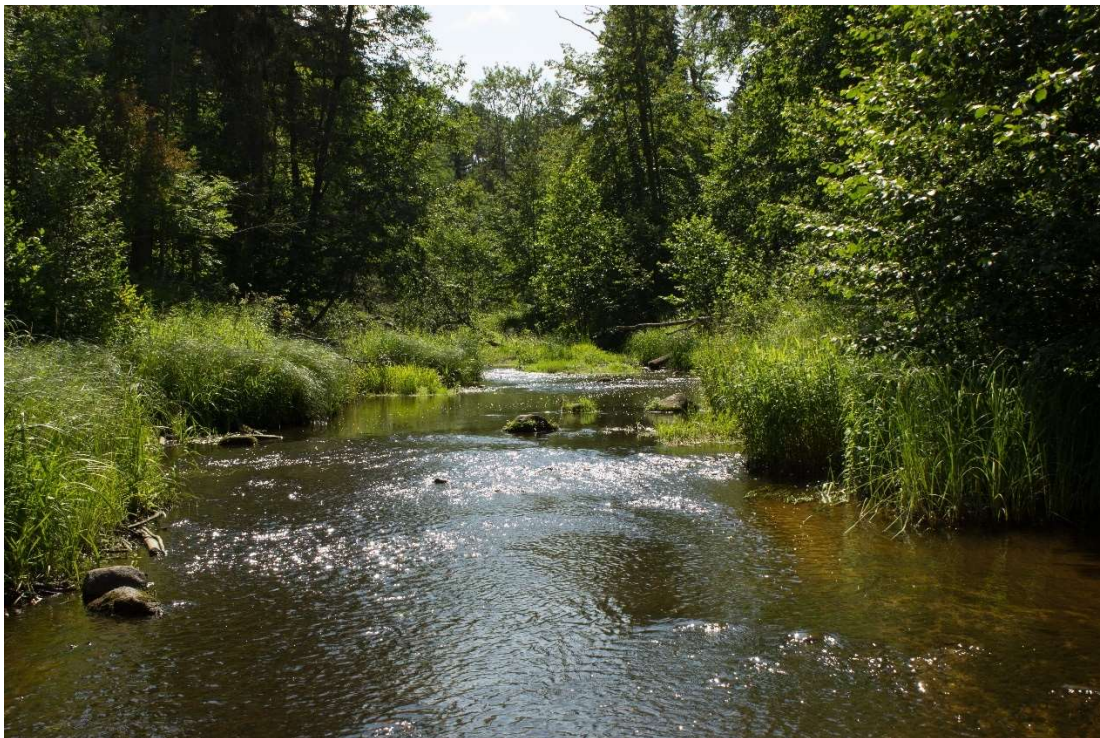
Figure 2.4.2 River Riežupe upstream the culvert

Evaluation of fish habitats has been done only in lower part of River Riežupe located between culvert and waterfall. Riverbed in this part of river is a mix of swift flowing and slower sections providing the river lamprey with a plenty of both spawning and rearing habitats.

Suitability of this section of river for river lamprey is also confirmed by monitoring of lamprey larvae which has been carried out since 2014 in one sampling spot located approximately in the middle of this section. Density of lamprey larvae in individual years in this site fluctuates between 10 and 33 ind./m² making an average value of 21.3 ind./m². Less data is available on next reaches and on River Veldze. In a section between waterfall and first dam only one electrofishing site and one lamprey larvae sampling site is located. Presence of brown trout, bullhead and other species in electrofishing as well as presence of lamprey ammocoetes in larvae monitoring confirms that in general this part of river is suitable for lamprey

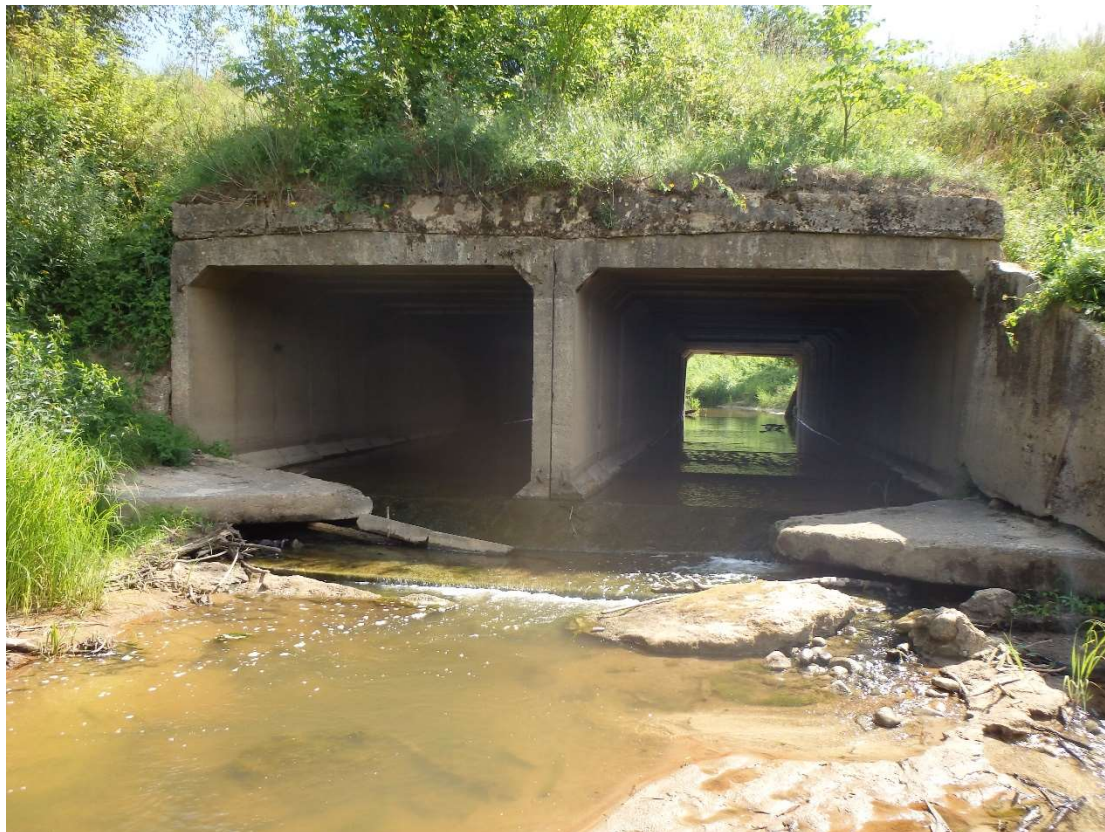
Figure 2.4.3 Culvert of local road in downstream section of River Riežupe

Culvert of the local road is located less than 100 m upstream of the river mouth. Culvert consists of two parallel square-shaped tunnels of reinforced concrete (Figure 2.4.3.).

Relatively wide and flat concrete bed induces hardly negotiable swift and monotonous current inside the tunnels. In addition, downstream side of this culvert has a relatively steep drop which is partly collapsed and followed by washed out riverbed thus making the entrance in culvert arduous for ascending lampreys. Difficult entrance and passage through the tunnels make this obstacle to be passable only during favourable conditions. Most convenient mitigation measure is to remove the present culvert and replace it with a culvert where bottom is covered by stones and gravel and resemble natural riverbed and

is on the same level as riverbed downstream the culvert. Since culvert is passable at specific conditions other measures such as building of a fish pass, translocation of spawners or stocking of lamprey larvae is not relevant in this case.

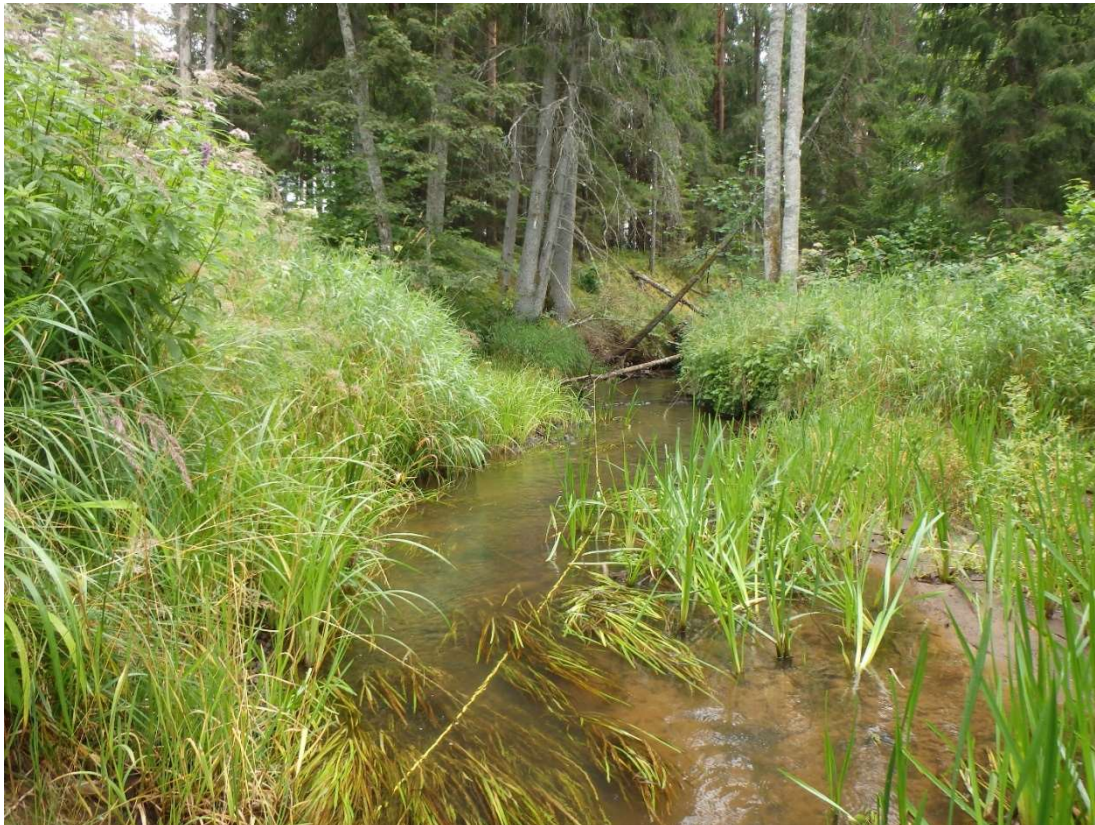
Figure 2.6.2 River Grīva upstream the former Uguņu watermill

river for lamprey reproduction is also confirmed by annual commercial catch of 100–300 kg of lampreys in this river. Detailed survey of habitats or monitoring of lamprey larvae in other parts of this river has not been performed. Electrofishing results upstream the former Uguņu watermill confirms the existence of brook lamprey population and the suitability of this part of river for the lamprey reproduction is confirmed also by the presence of bullhead and brown trout.

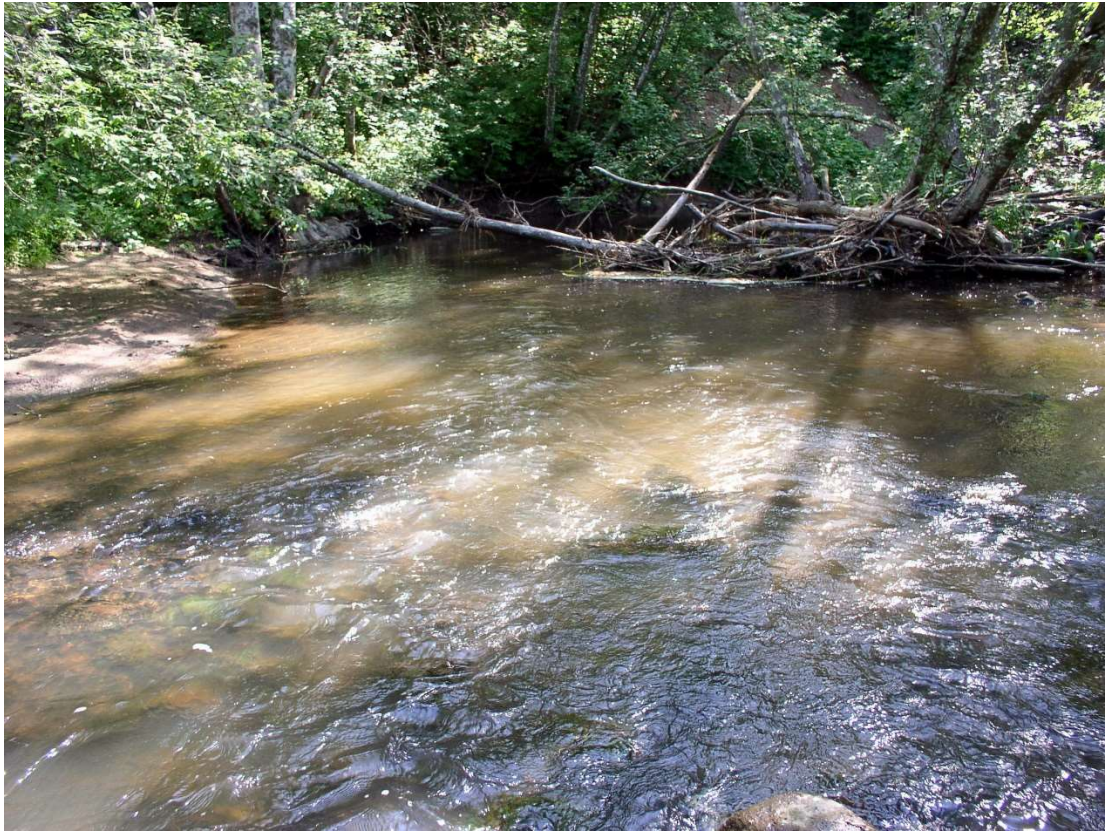
Figure 2.8.2 River Virga upstream of the Prūšu HPS

captured only in lowermost electrofishing site located approximately 10 km from river mouth (Figure 2.8.2). However, presence of such species as brown trout and bullhead in electrofishing site located approximately 24 km from river mouth suggests that this part of riverbed is also suitable for lamprey reproduction. There are only two noteworthy tributaries emptying in River Virga upstream of the barriers. River Niedrupīte is 7.4 km long and most of its riverbed is straightened. In the same time River Dobeļupe is only 2.2 km long but has preserved natural riverbed in almost all its length.

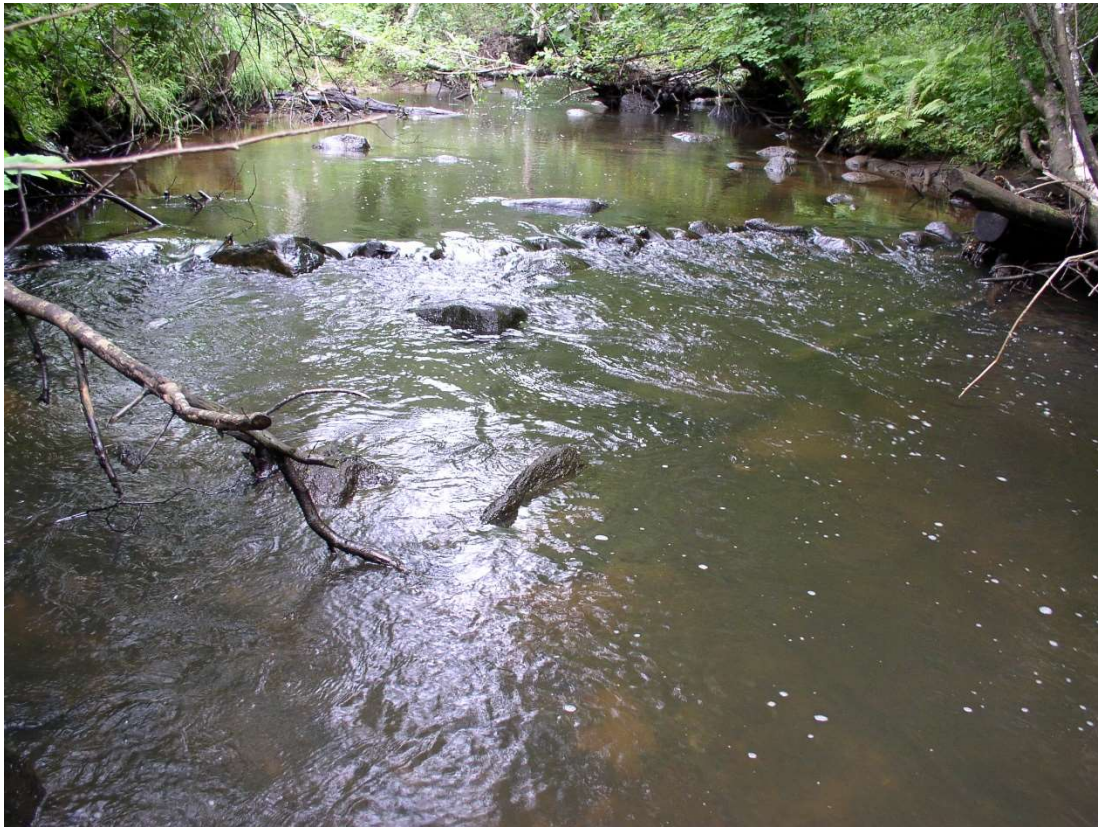
Figure 2.9.2 River Pāce downstream the Pāces HPS

No detailed survey of habitats or monitoring of lamprey larvae has been performed in River Pāce or its tributaries. Known electrofishing sites are located downstream of both barriers and electrofishing results in these sites (lamprey larvae trout parr, bullhead etc.) confirm that downstream section of River Pāce is well suited for lamprey reproduction.

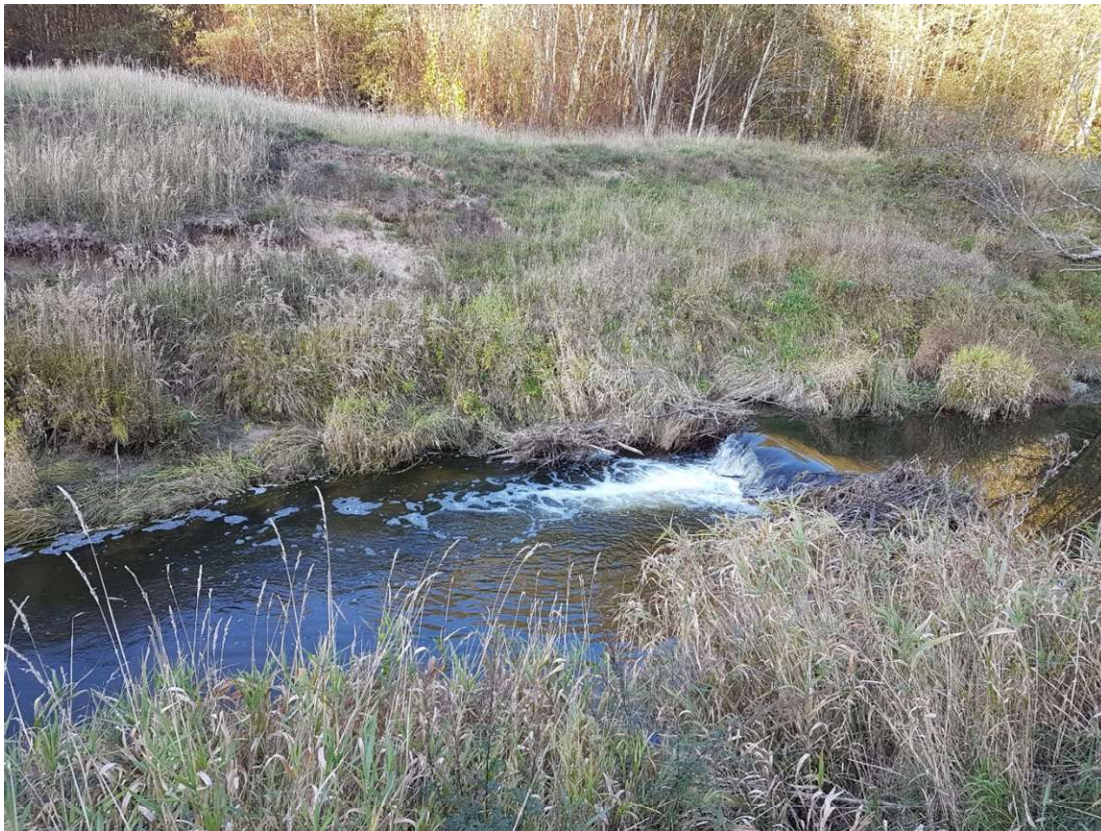
Figure 2.10.3 One of the beaver dams in the River Durbe

Both barriers are big beaver dams (Figure 2.10.3) and mitigation measures in both cases is removal of existing dams and regular survey of river to see if dams have not been rebuilt. It is also recommended to regulate the beaver population. Lamprey reproduction potential in upper reach of River Durbe and in several of its tributaries can be increased also by river restoration.

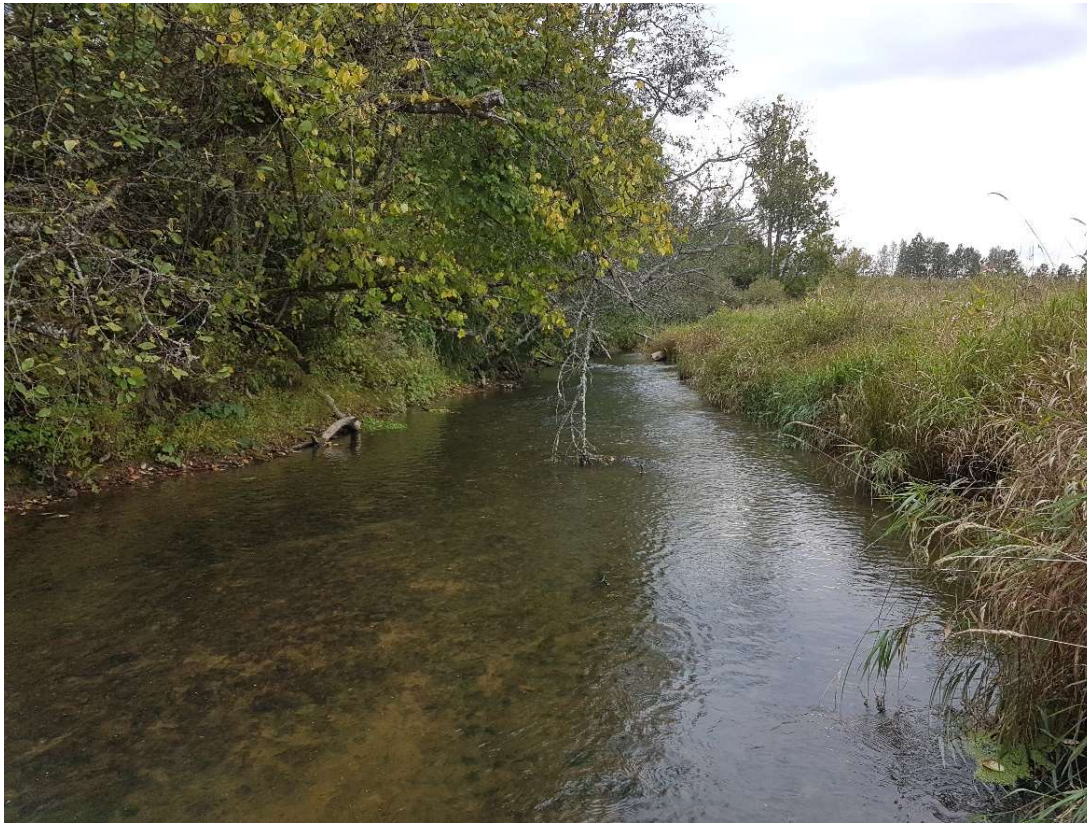
Figure 2.11.2 section of River Tebra suitable for spawning of lampreys and salmonid fishes

Habitat mapping has been performed in approximately 50 km long middle and lower section of River Tebra. Mapping of riverbed confirms that in addition to the slow flowing sections suitable for rearing of lamprey larvae there are also more than 0.7 ha of fast flowing sections suitable for spawning of salmonid fishes and lampreys (Figure 2.11.2), and these rapids are separated by sections with a good rearing habitat for lamprey larvae.

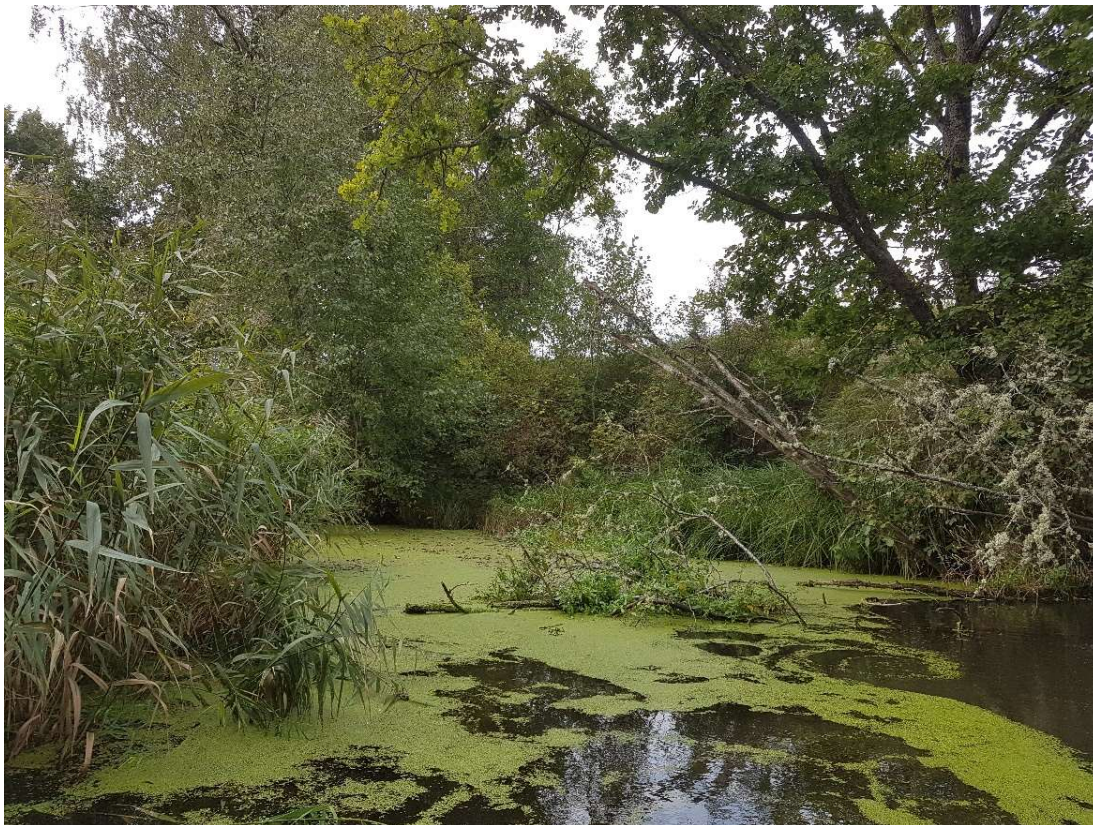
Figure 2.11.3 Section of River Tebra upstream the beaver dam

Noteworthy impact on lamprey migration also lies with the cascade of large beaver dams located approximately 22 km downstream of the Aizpute watermill. These dams can be passed at high flow or other suitable conditions yet they slow down the pace of migration and increase the consumption of energy. Such dams also reduce the area of potential spawning biotopes (Figure 2.11.3). The only convenient solution is regular removal of the largest dams and if possible reduction of beaver population.

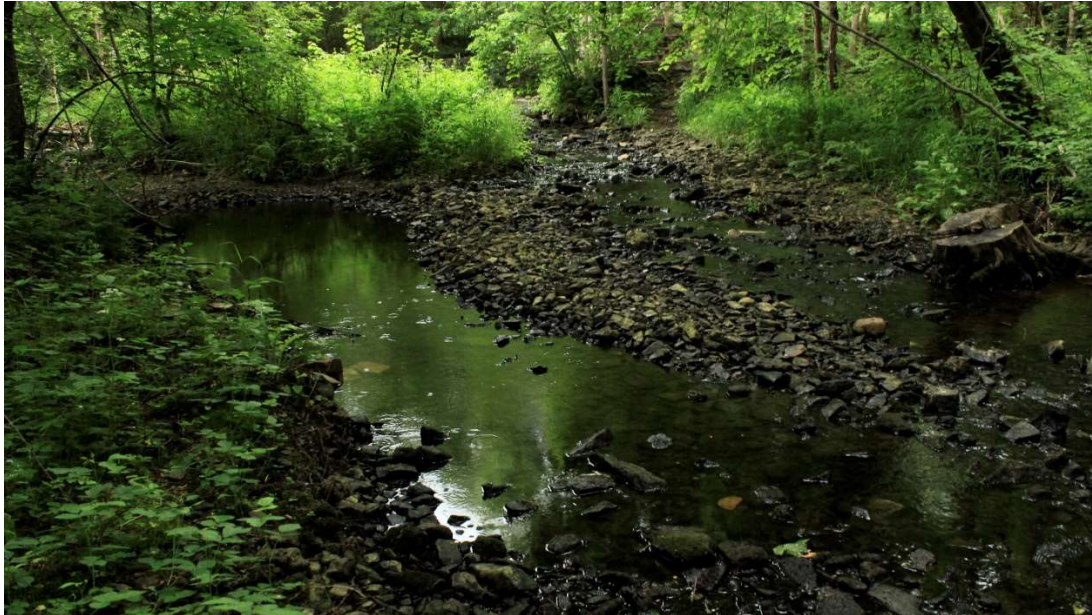
Figure 2.17.2 River Īlande downstream of the waterfalls

highly possible that migrating lampreys enter all of its tributaries. In addition, suitability of downstream reach for reproduction of river lamprey is indirectly confirmed by high abundance of bullhead in electrofishing site downstream the waterfalls (Figure 2.17.2).

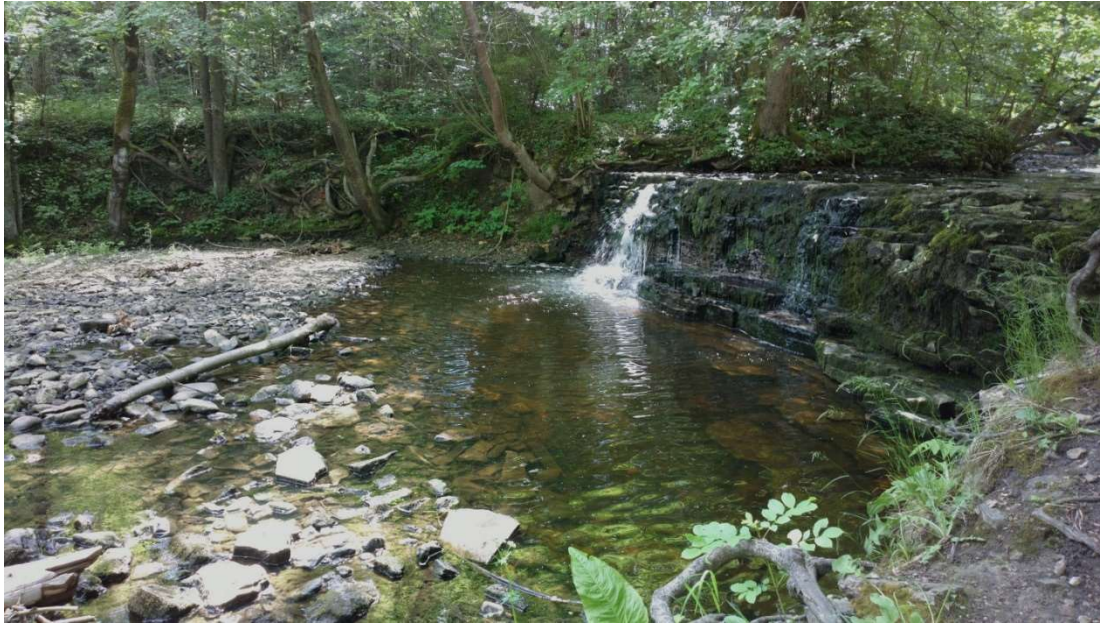
Figure 2.17.3 Lowermost of waterfall in River Īlande

Most important barrier for upstream migration is cascade of two 1.5 m (Figure 2.17.3) and 2 m high waterfalls located only 0.5 km from the riverbed. Both of them have a status of protected geomorphological site and due to their size normally cannot be passed by migrating lampreys.

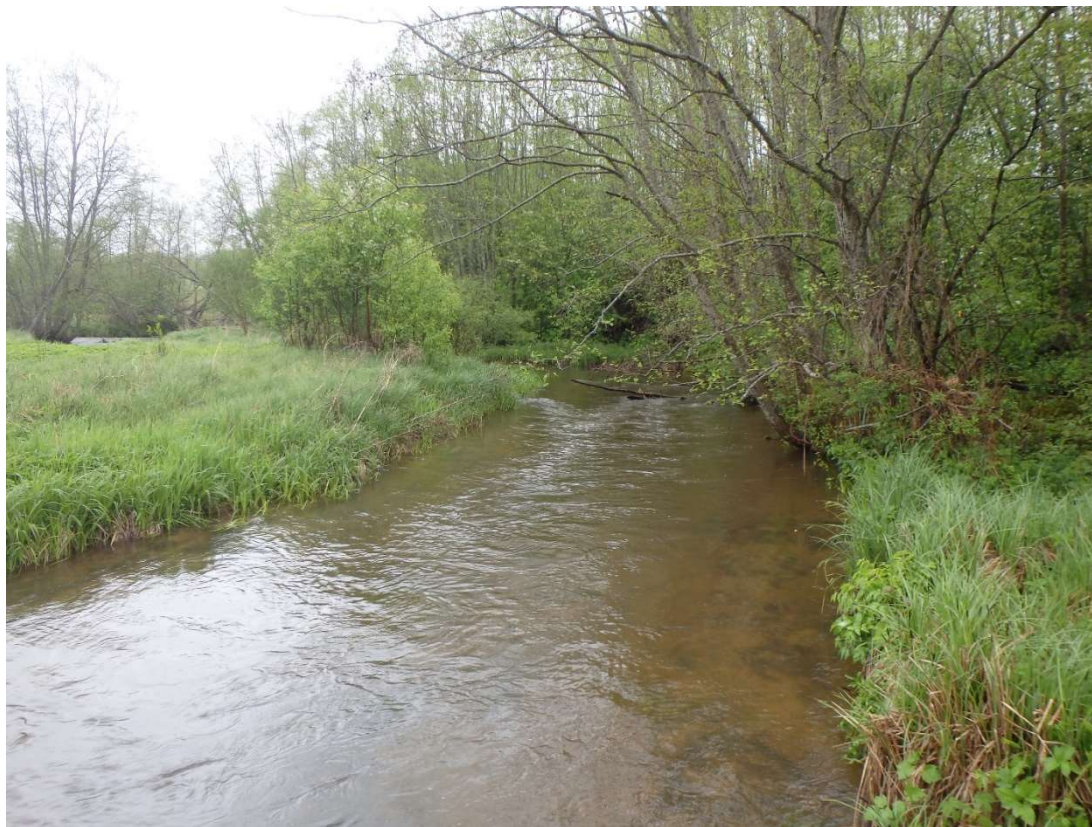
Figure 2.18.2 River Svente downstream of the Sendzirnavas HPS

Entrance or river lamprey for spawning in this river is confirmed by capture of lamprey larvae in electrofishing sites located downstream the barriers (Figure 2.18.2).
